Seismic Evaluation – Phase 2: Report

Sonoma County – Chanate Hospital

ZFA Project: 14565

February 13, 2015

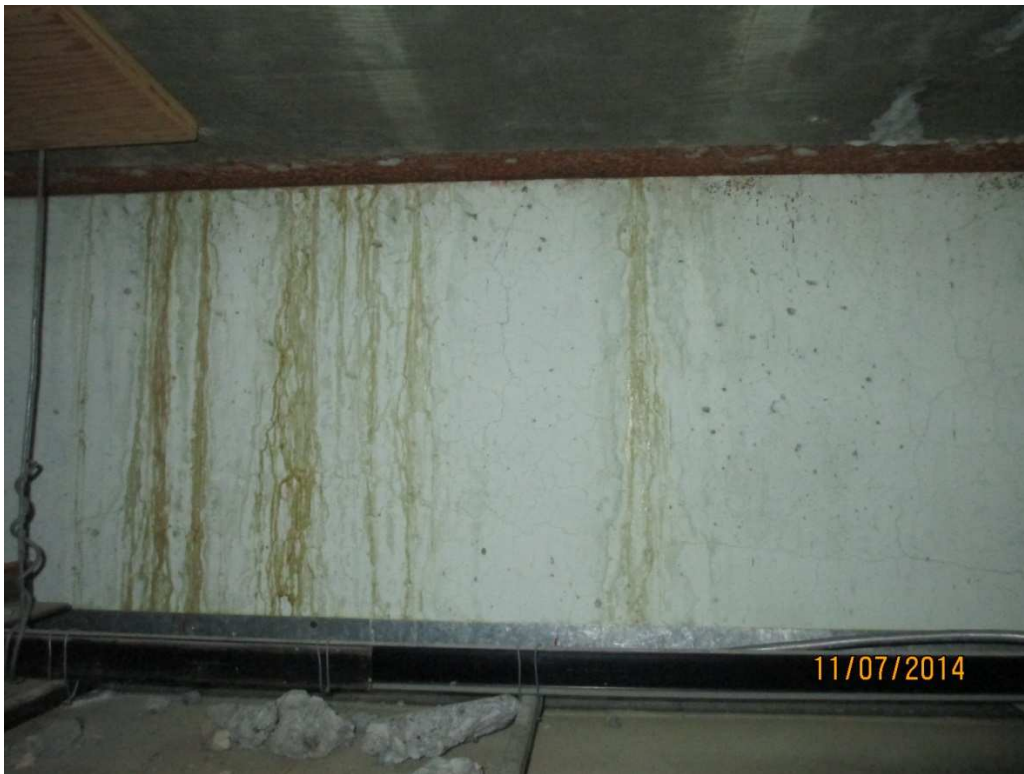
- The steel ledger connecting the concrete roof slab of Building 6 to Building 5 is the critical connection in the seismic performance of building 6. The connection utilizes archaic expansion anchors to transfer in-plane and out-of-plane forces to the Building 5 lateral system that have no reliable tensile capacity. It is recommended a new steel ledger be welded to the existing ledger and attached to the Building 5 concrete walls with adhesive anchors meeting current code requirements.

Photo 13: Building 6 – Rust signs at steel ledger

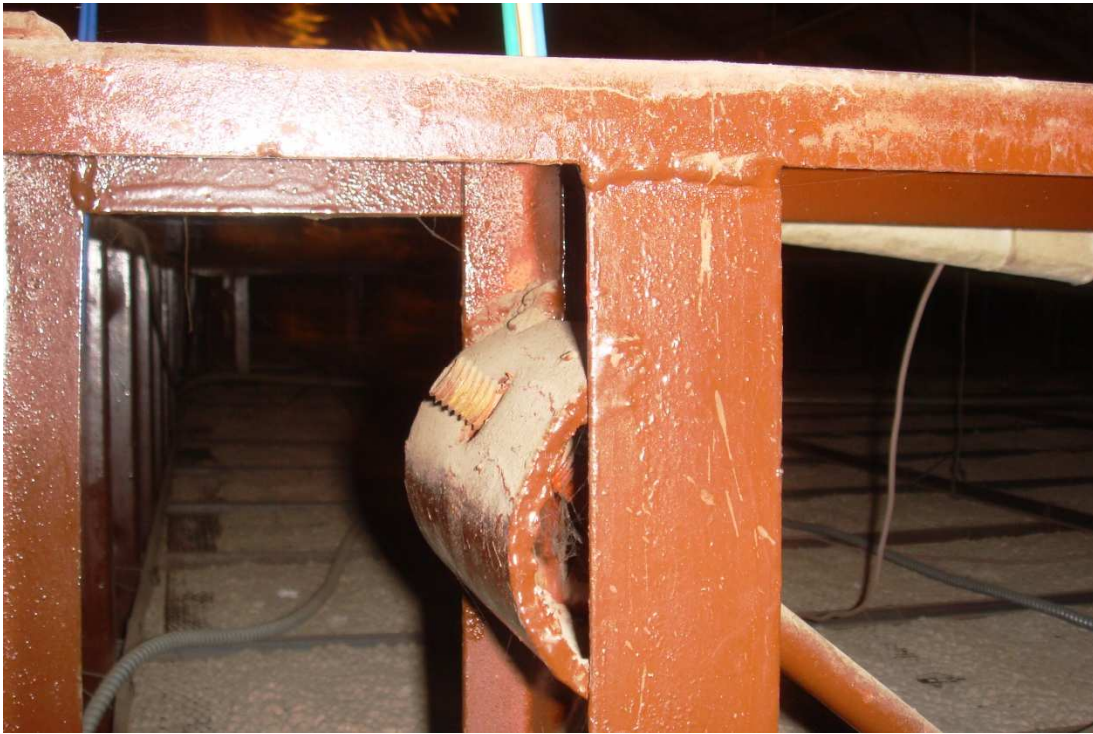
- The lateral force resisting system, consisting of diagonal rod braced wall panels, lacks load path and is severely deficient. Load path issues include, but are not limited to:
 - Chords and collectors are neither well-defined nor detailed for seismic forces at the roof diaphragms. Minimal structural continuity exists, consisting of thin gage metal tracks with long unbraced lateral lengths and minimal splices.

Photo 7: Interior Braced Wall Panel End Connection above Ceiling (note missing nut)

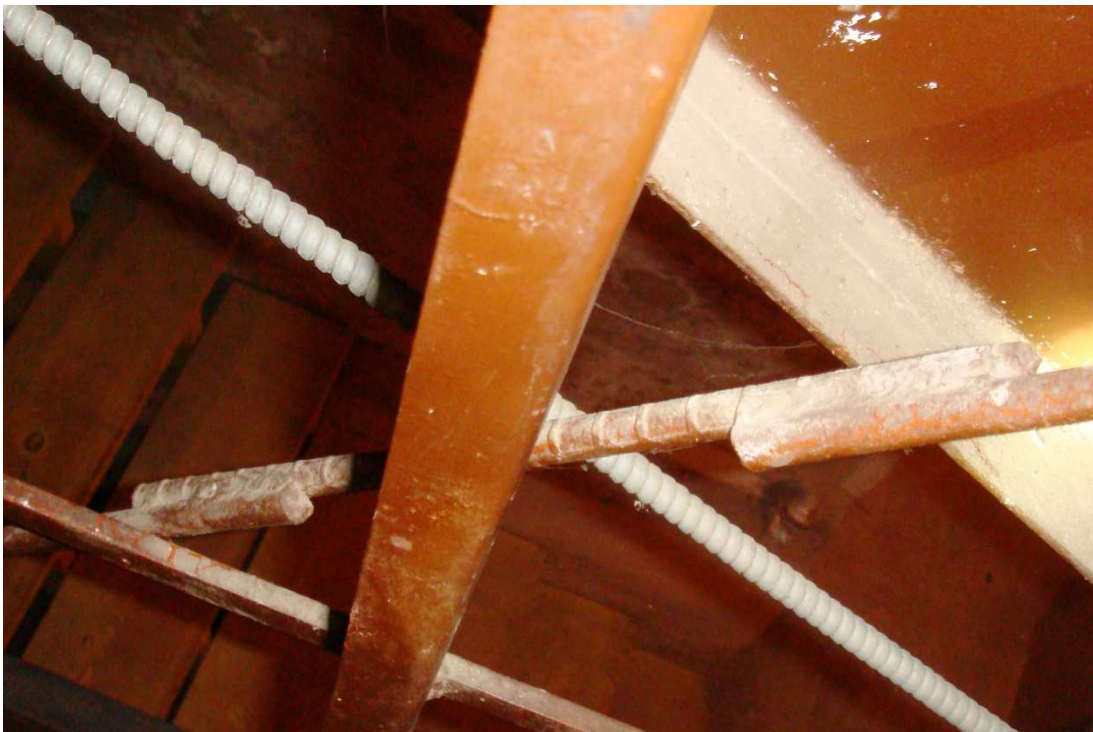
Photo 8: Diagonal Rod Splice (note use of rebar and eccentric lap splice)

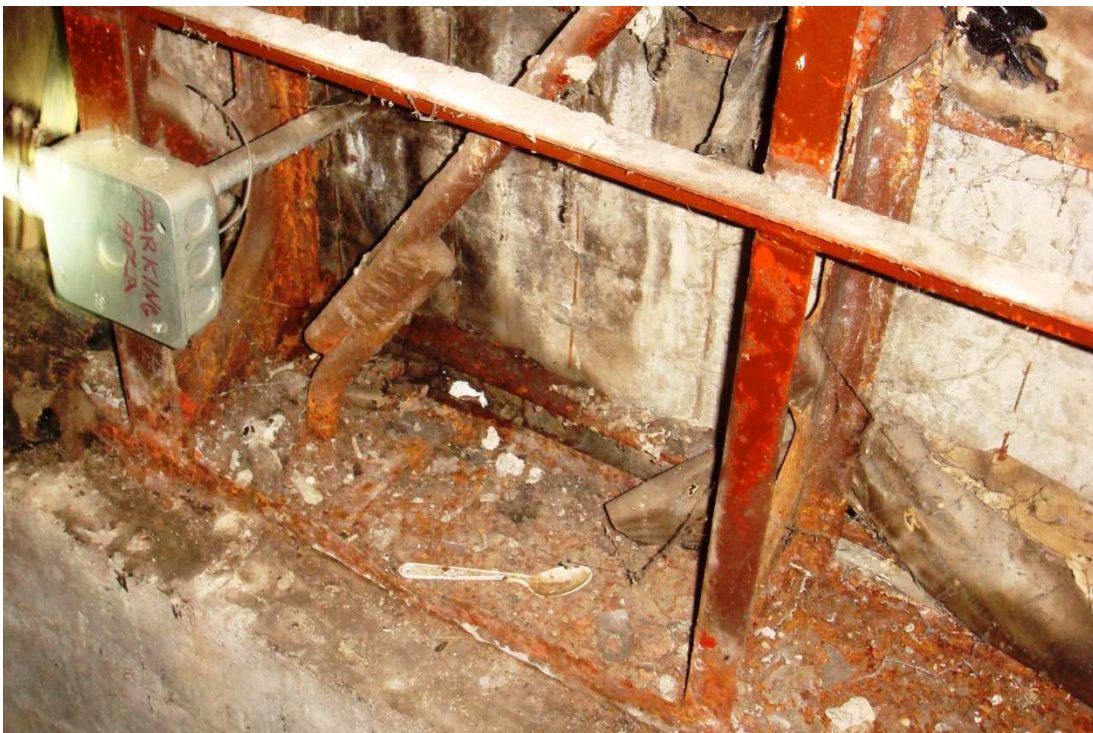
Photo 10: Diagonal Rod at Basement Wall (note bent anchor stub at the left and sill track corrosion)

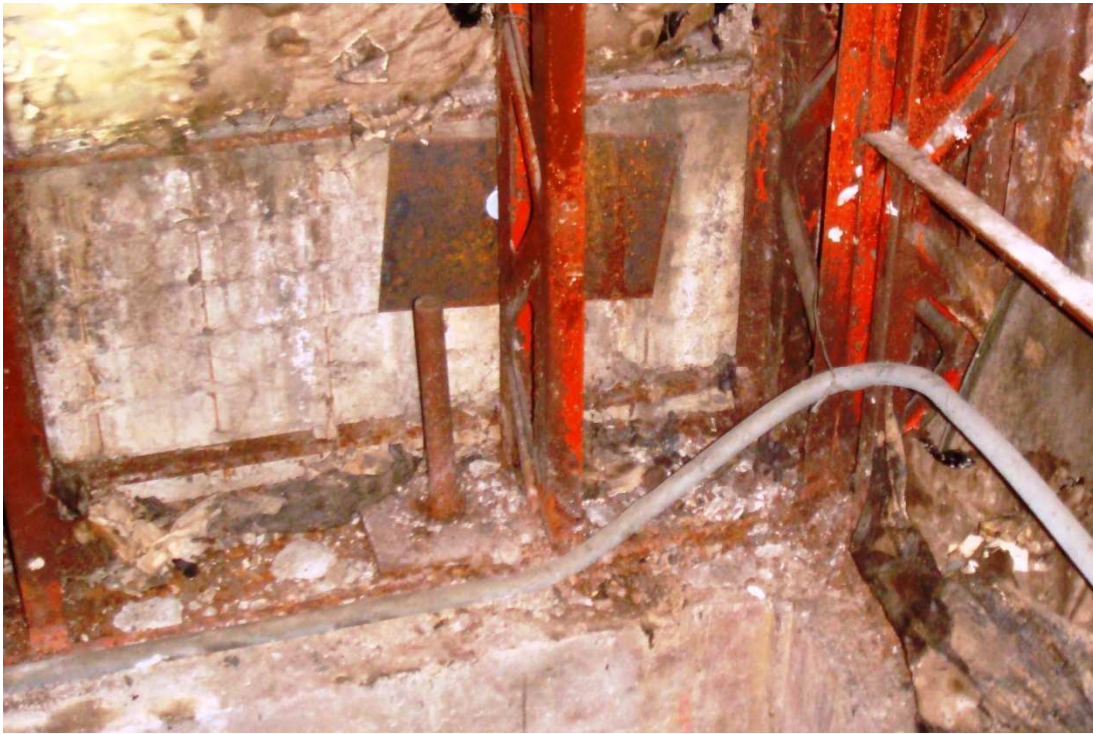
Photo 11: Missing Rod at Basement Wall (note unused anchor stub at the left and sill track corrosion)

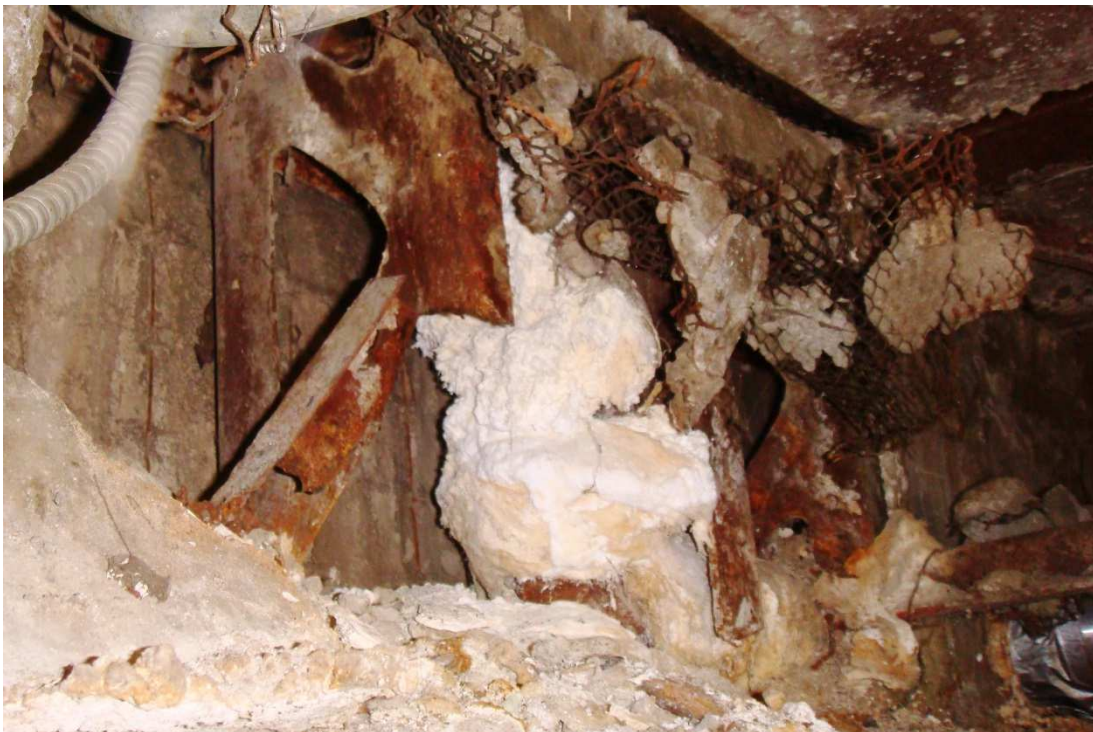
Photo 12: Cripple Studs at Basement Wall (note cut and bent stud at the left and corrosion)

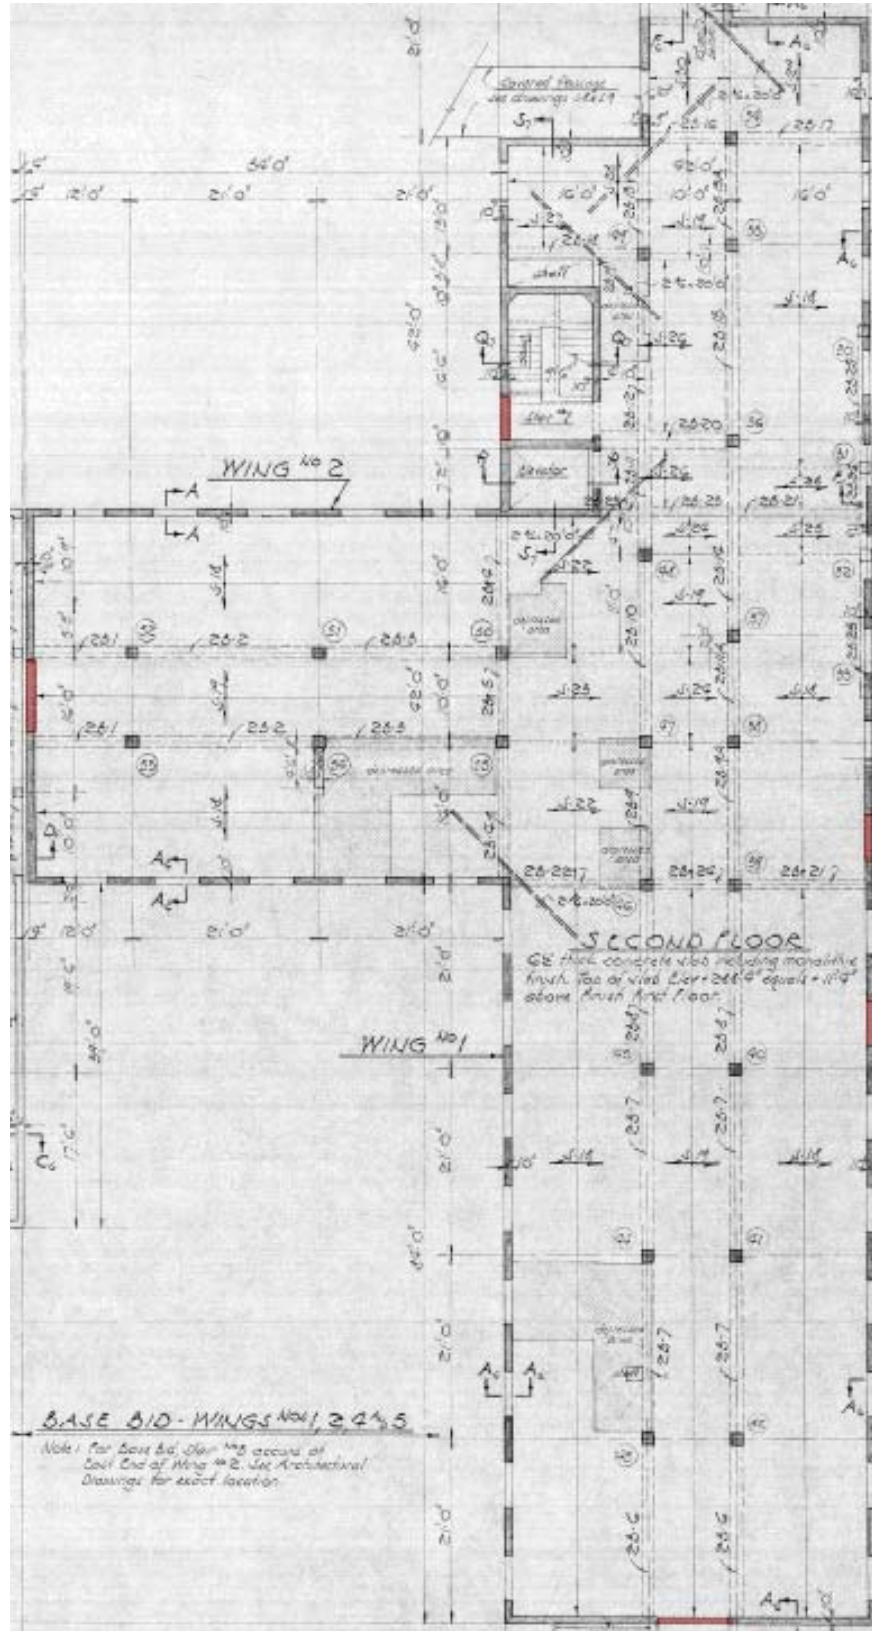
BUILDING 3 – JACKETED CONCRETE BEAM LOCATIONS (SHADED IN RED)

- Stirrups in concrete beams over means of egress do not have proper hook configurations. Jacketing beams with fiber reinforced polymer (FRP) strips or steel plates is recommended as means of controlling localized damage from a seismic event and adding ductility/resiliency to this 'fuse' type member.
